Manhole Inspection Summary

Manhole # S29II1037MH

Insp Date: **4/16/07 10:25 AM**

Location Address: **4209 WICKFORD RD**

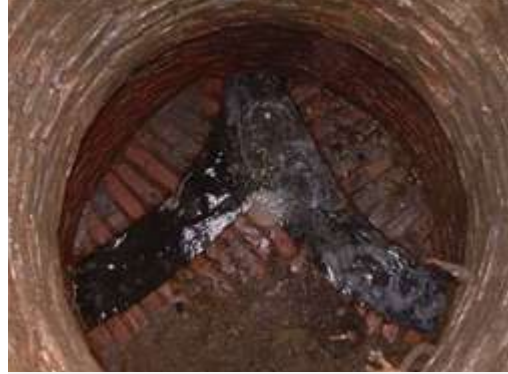
Top View

Corroded and missing steps. Evidence of surcharge - Bench debris. Channel debris.

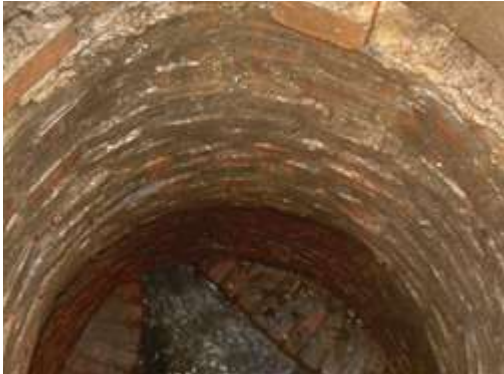
Defect

Frame leaks. Adjustment deterioration, loose brick and infiltration.

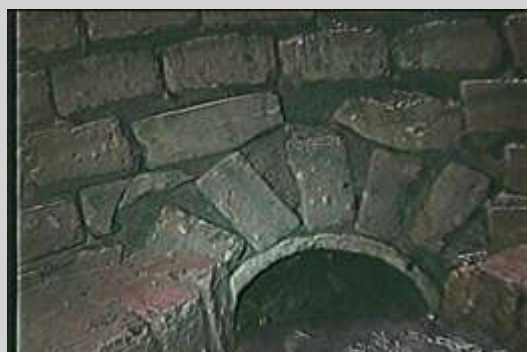
Pipe Out @ 12 O'Clock

Deposits: ☐ None ☒ **Mud** ☐ Sludge ☒ **Debris** ☐ Grease

Silt Depth: **1** (in.) Deposits Extent: **Light**

Infiltration: **None** Pipe Seal Cond: **Unknown**

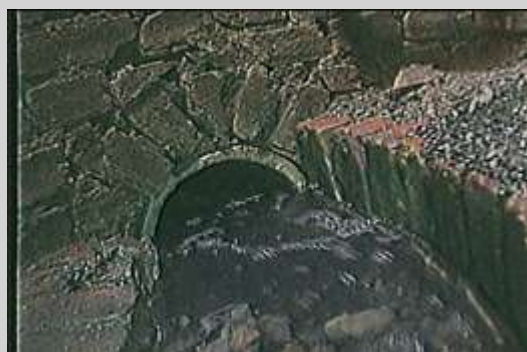
Pipe In @ 4 O'Clock

Barrel deterioration and infiltration.

Deposits: ☐ None ☒ **Mud** ☐ Sludge ☒ **Debris** ☐ Grease

Silt Depth: **3** (in.) Deposits Extent: **Medium**

Infiltration: **Evidence** Pipe Seal Cond: **Cracked**

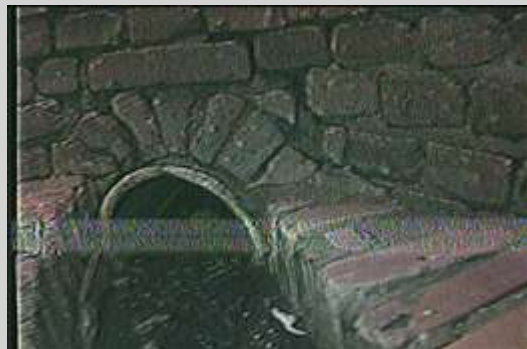
Pipe In @ 8 O'Clock

Deposits: ☐ None ☒ **Mud** ☐ Sludge ☐ Debris ☒ **Grease**

Silt Depth: **2** (in.)

Deposits Extent: **Medium**

Pipe Seal Cond: **Cracked**
